KONKOLA MINE

RE: BI-ANNUAL STATUTORY REPORT FOR KMRL KONKOLA MINE

**BI-ANNUAL REPORT TO THE ZAMBIA ENVIRONMENTAL MANAGEMENT AGENCY
(ZEMA) FOR THE PERIOD JULY TO DECEMBER 2023**

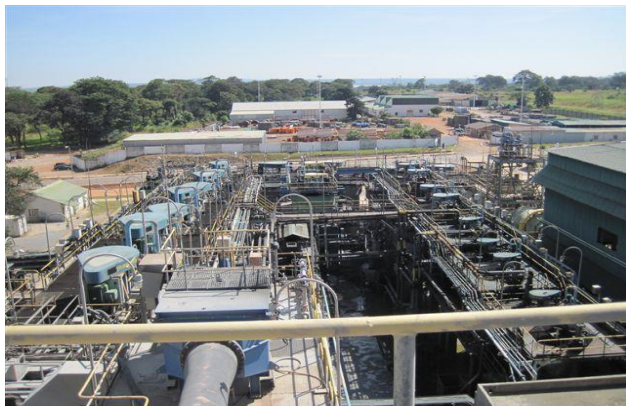
Fig.1: Concentrator Plant

1.1.1 Storage – All process reagents are kept at the central storage shed and transported on demand to the reagent mixing shed, which is under a roof and adequately bunded. The store is sized to hold approximately twelve month's operating requirements. A summary of the storage and use of reagents in the reporting period is provided in Table 1 below.

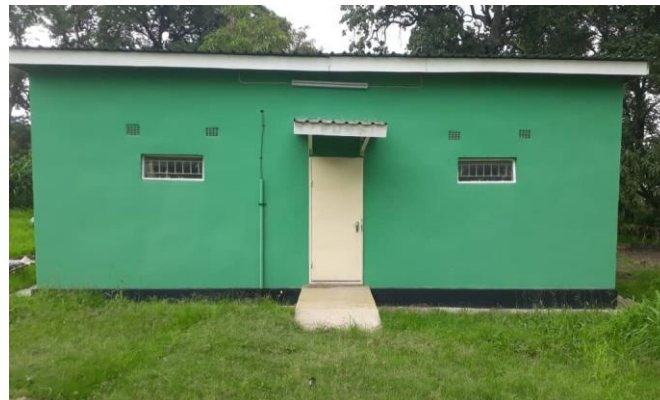
Fig.6: Pesticides Storage Facility

KMRL-Konkola Public Health Department uses a number of pesticides to control various pests that may pose a danger to the workforce and the general public within our area of operation. In order to prevent the risks associated with these substances including potential misuse, spills, and accidental human exposure, the department ensures safety guidelines for the storage, transport, and use of pesticides are applied into day-to-day activities. Table 4 below provides a summary of the pesticides usage and quantities in stock. No pesticides and toxic substances were stored at Konkola storage facility in the reporting period as the facility was temporarily suspended for use and rehabilitation works have just been completed. During the period under review, all substances used were collected from Nchanga Public Health Centre and used upon demand.

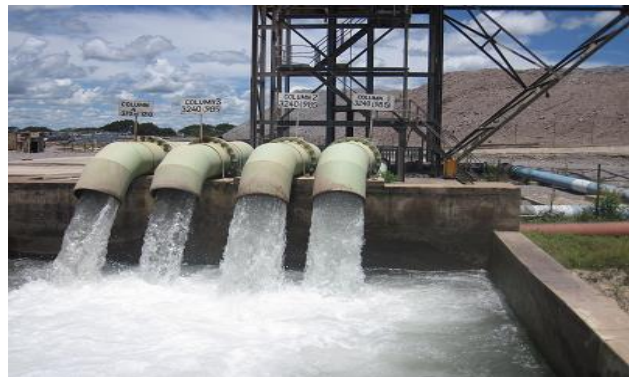
Fig.8: Pipe Columns from Underground

In order to dewater the Konkola underground mining operations, water is pumped from underground via the following multiple pipes:

- Two 500 mm (16”) diameter pipes (new and old) and one 600 mm (20”) diameter pipe which provide the process water for the concentrator plant
- One 1200 mm (48”) diameter pipe, which discharges directly to the environment
- One 200 mm (8”) diameter pipe, which discharges directly to the environment
- One 600 mm (20”) diameter pipe, which is treated in sedimentation ponds for domestic water use
- One 200 mm (8”) diameter pipe, which is treated in sedimentation ponds before discharge to the environment
- One 200 mm (8”) diameter pipe, which is treated in a 250ft thickener before discharge to the environment
- Four 500 mm (16”) diameter pipes, which discharges directly to the environment

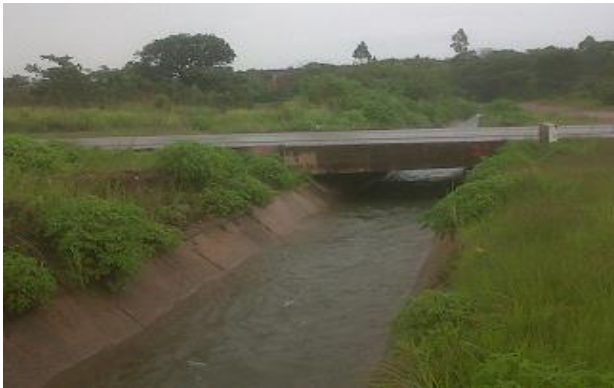
Fig.9: Lubengele Tailings Dam Overflow

The tailings from the existing concentrator are presently pumped to the Lubengele Tailings Disposal Facility. Overflow from the tailings dam is conveyed to the discharge point through the spillway. Accordingly, samples of discharge water are collected from the concrete channel downstream of the tailings facility (Discharge point 208). Table 10 below provides a summary of the monitoring results for the tailings dam overflow in the reporting period. Details of related incidents and causes are provided in table 10.

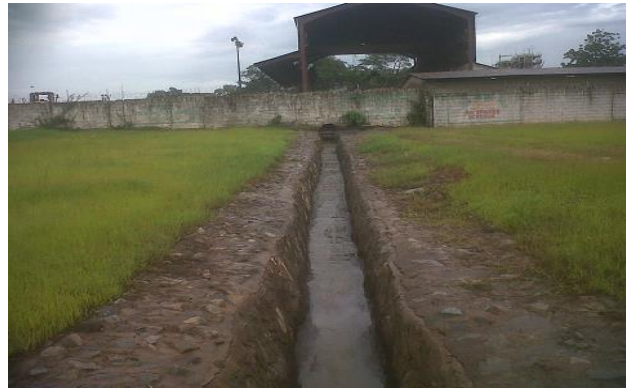
Fig.10: Engineering Workshops Drain

Routine service, repair and overhauls of equipment as well as cleaning of fuelling facilities require the use of water to a limited extent. Accordingly, samples of discharge water are collected from the concrete channel downstream of the central workshops on surface workshops at Engineering Services (Discharge point 225). Table 11 below provides a summary of the monitoring results for the engineering workshops overflow in the reporting period. Details of related incidents and causes are provided in table 14.

July, October	Equipment maintenance and repair (225)	Turbidity was above the statutory limit at Engineering Drain-209: in July (43.19) and October (16.73) against (15)	Contaminated material from the immediate surroundings washed/carried over into the drain.	Effective implementation of water pollution control procedure (KMRL-EP-01).	On-going
August	Equipment maintenance and repair (225)	Color was above statutory limits at Engineering drain-225 in August (26) against (20)	Natural Occurrence	N/A	On-going
September & December	Equipment maintenance and repair (225)	Calcium was above the statutory limit at Engineering Drain-225 in September (140.22mg/l) in December, (104.65mg/l) against 100mg/l Limit.	Contaminated material from the immediate surroundings washed/carried over into the drain.	Effective implementation of water pollution control procedure (KMRL-EP-01).	On-going

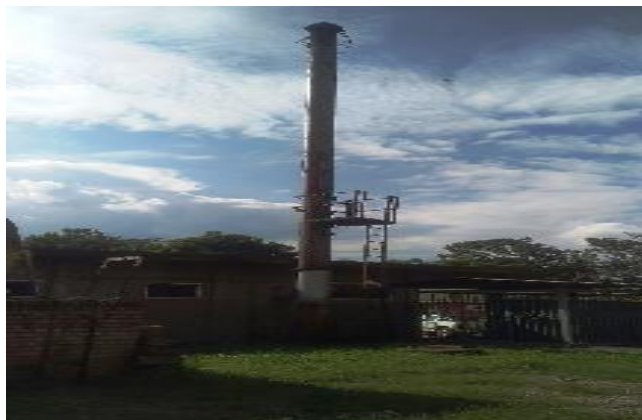
Fig.11: Hospital Incinerator Stack

- Solid waste from the mine hospital, including contaminated medical waste, is collected at the hospital, incinerated and the waste ash disposed of at the designated incinerator ash disposal facility which is a concreted below ground pit located about 800m on the southern side of No. 4 shaft.

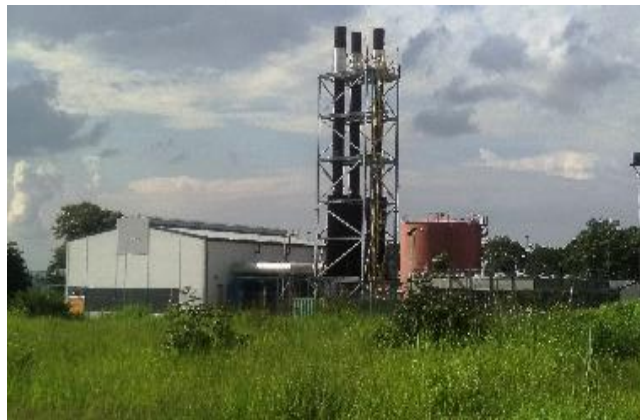
Fig.12: Diesel Generator Stacks

The diesel generators were installed to provide power required for ventilation, man riding and pumping in an emergency. Table 13 below provides a summary of the monitoring results for the stacks. Details of related incidents and causes are provided in table 14.

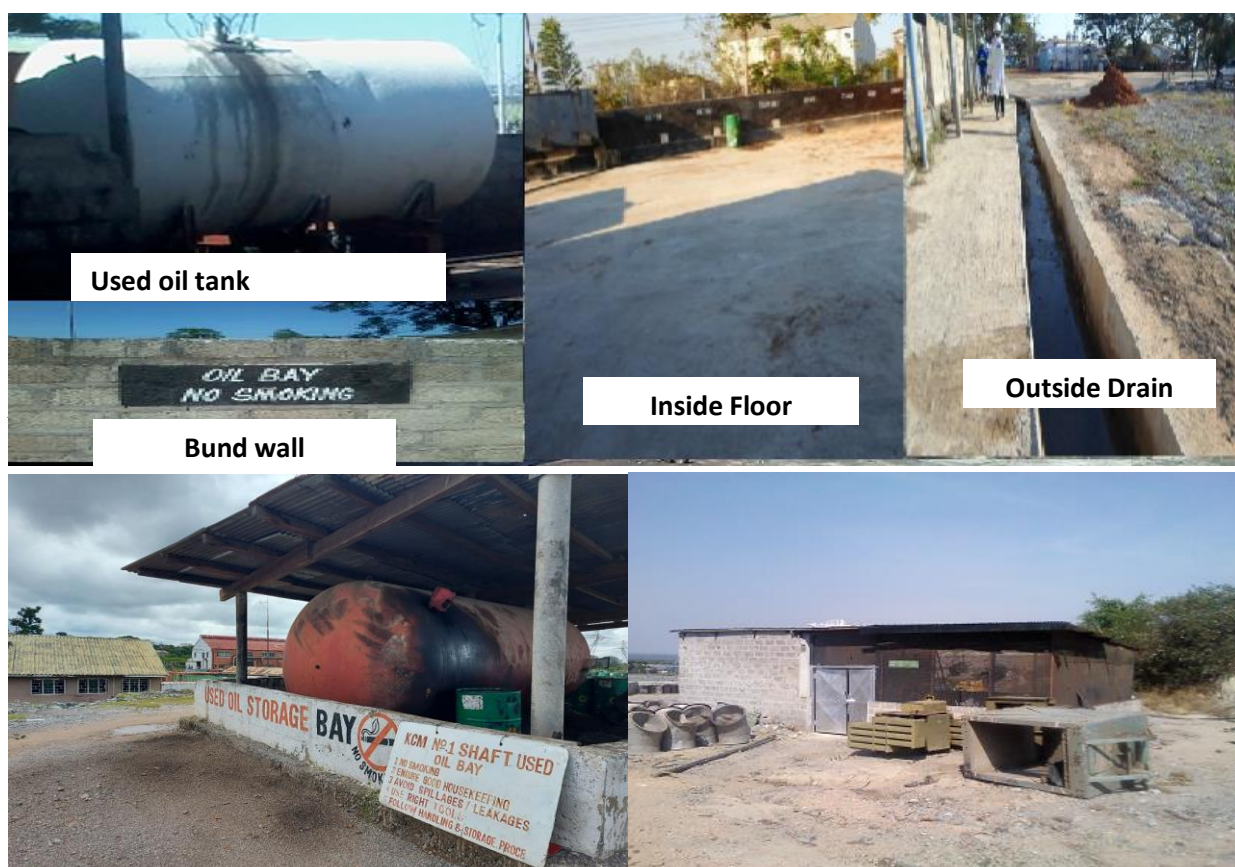
Fig.14: Used Oil Store – Shaft 1

The plant generates hazardous waste namely; waste oil, used fluorescent tubes and used batteries. Waste oil is stored on constructed bays with impervious floors and bund walls and eventually reused at Nchanga Smelter as fuel. Spent fluorescent tubes are stored within the plant premises in fabricated storage drums while batteries are stored in the hazardous materials store before it is disposed of through recycling/reuse contractors. The quantities generated are presented in table 15 below.

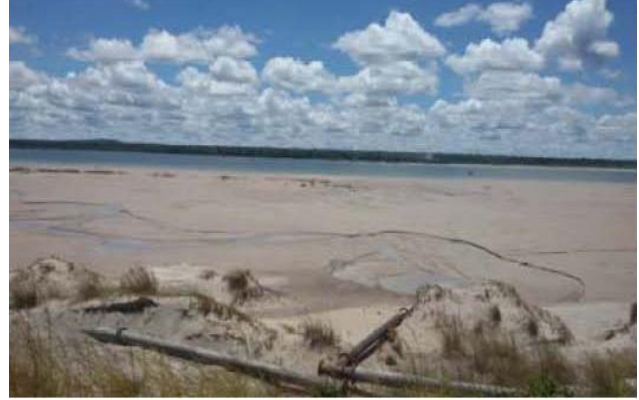
Fig.17: Lubengele Tailings Dam Beach

In order to ensure safe operating conditions of the tailings dam, Konkola mine has engaged an independent consultant [Knight Piesold] to conduct periodical assessments. Below is a summary of the status of the dam.

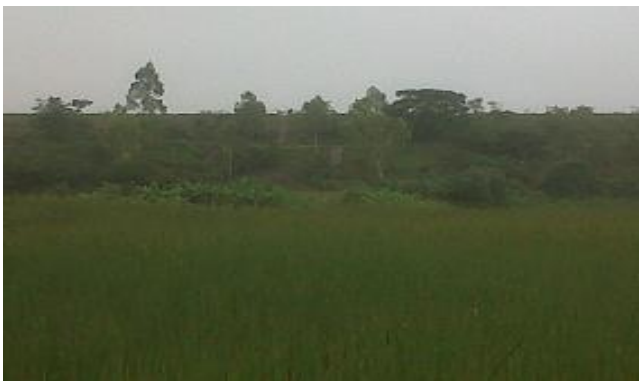
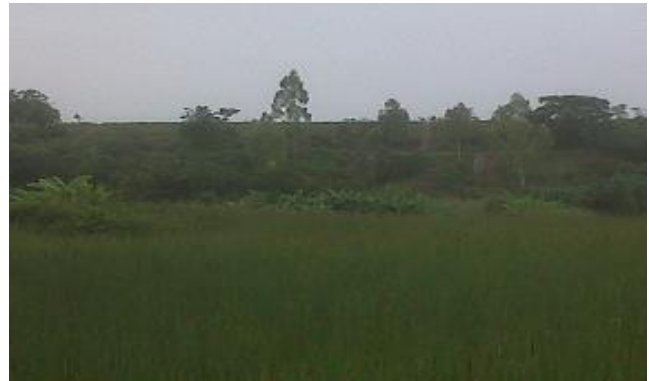
Fig.18: Lubengele Tailings Dam Wall

The eastern embankment of the tailings dam which susceptible to dust is generally maintained in good order with vegetation well established on most portions of the slope. There were no community complaints in the period under review

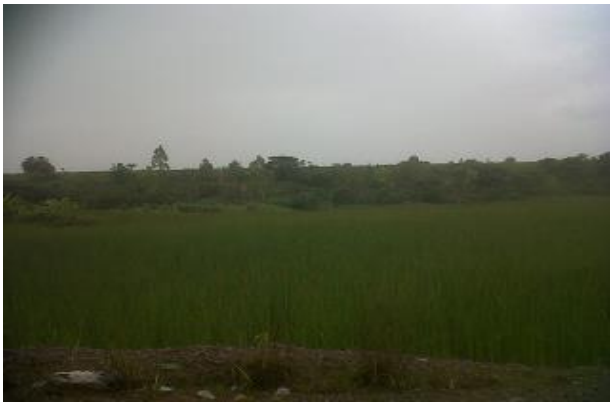
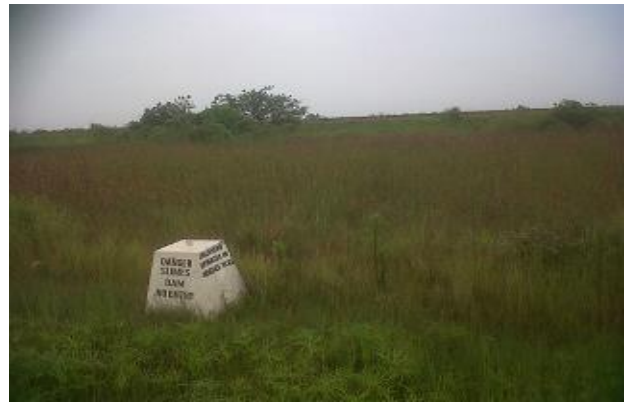
Fig.20: Lubengele Tailings Dam Surrounding

Work towards revegetation of areas of the tailings embankments to reduce on erosion is undertaken on an ongoing basis. The replanting involves a selection of tree and grass species and stock is obtained from local suppliers.

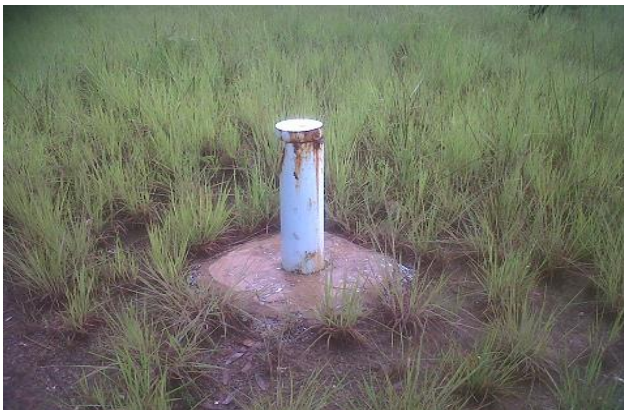
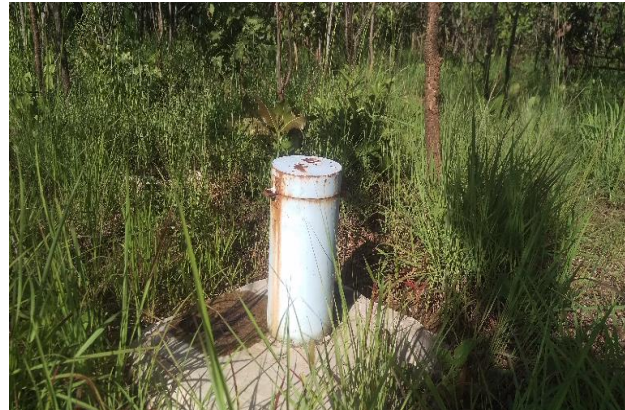
Fig.22: Lubengele Tailings Dam Borehole

There are a number of dug wells adjacent to and upstream of the dam. Table 15 below shows the quality of groundwater around the dam. SDH19 and SDS01 are controls.

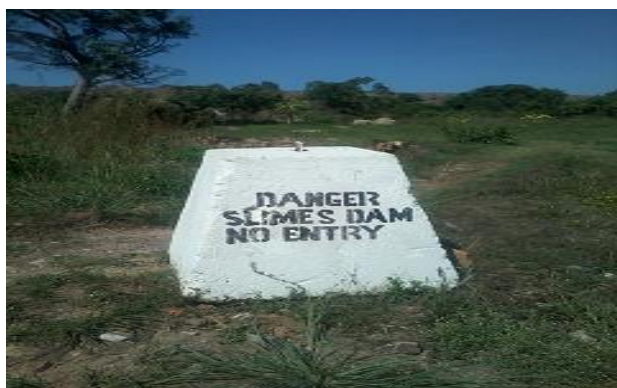
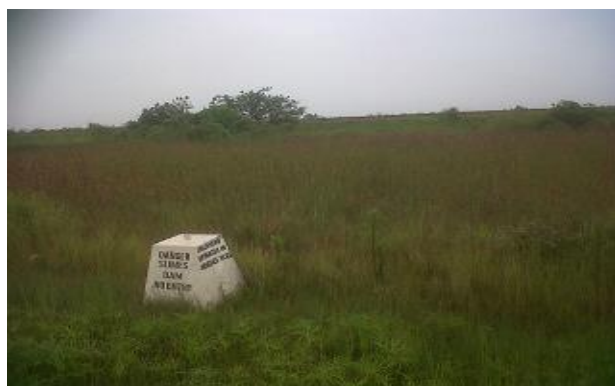
Fig.24: Lubengele Tailings Dam

The tailings dam is a vast area and therefore no fencing has been provided to restrict access. However, in order to prevent illegal entry by unauthorized persons, appropriate warning signage is displayed at various points around the dam. The perimeter is also under 24 hours surveillance by Mine Security Personnel. Despite all the effort, illegal fishing and washing of clothing is occasionally practiced. Due to the fact that unauthorised fishing from the dam could represent a health risk, fish and water quality from the dam is periodically tested. Sampling of fish and water from the Lubengele Tailings Dam was conducted in the review period.

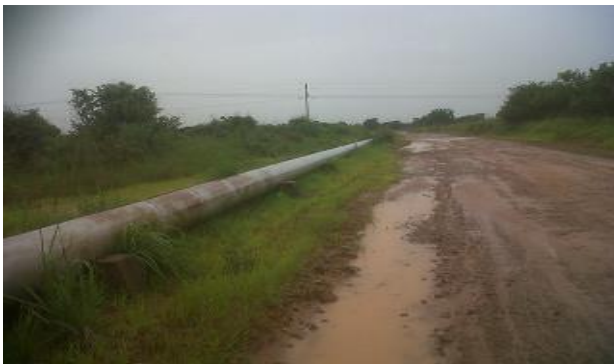
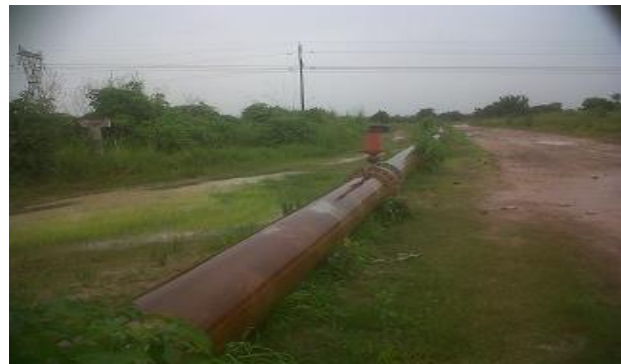
Fig.28: Lubengele Tailings Pipeline

- The tailings pipeline is a 300 mm diameter, 8.4 km long rubber lined steel pipeline which delivers tailings from the process plant for disposal in the tailings facility. The pipeline was newly installed with a 25 year guarantee. A second tailings pipeline is available for use during maintenance of the main pipeline.

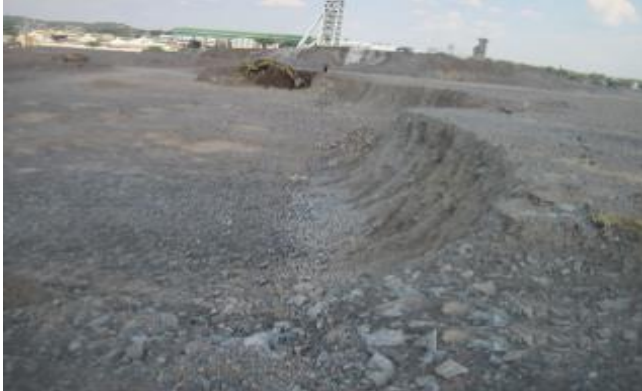
Fig.30: Waste Rock Dump A

Monitoring of the waste rock dumps is undertaken on an ongoing basis regarding volumes of waste rock disposed on the dumps and visual inspection for sign of instability and/or erosion.

The dumps are generally well maintained. Both dumps are currently being reclaimed for building/construction material. Slopes are stable and top surfaces well maintained. Tension cracks are filled as they appear.

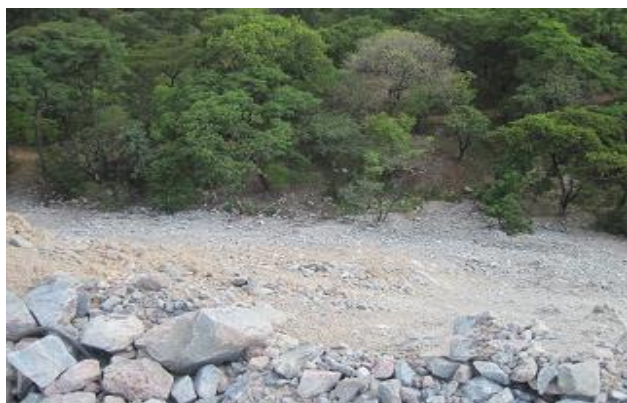
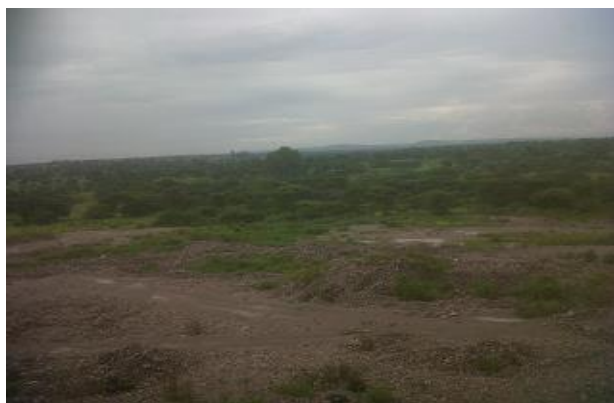
Fig.34: Waste Rock Dump A

There is no vegetation on the dump. The surrounding areas are however well vegetated with no evidence of negative effects arising from erosion.

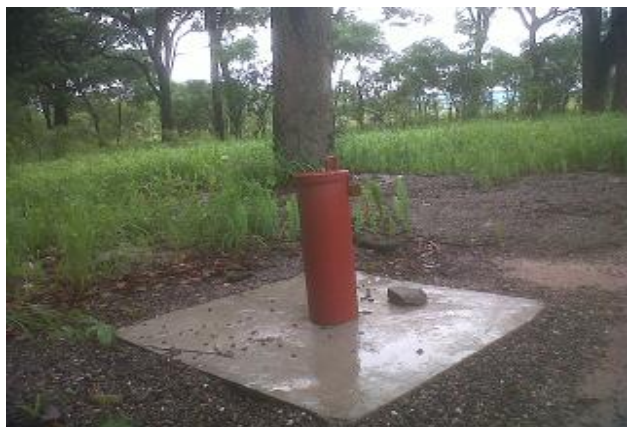
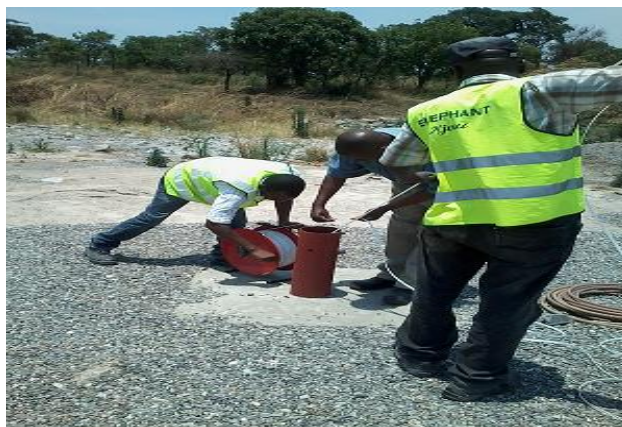
Fig.36: Waste Rock Dump A Borehole

There are two monitoring boreholes on each waste rock dump to monitor the quality of groundwater to ascertain whether our operations are impacting on the groundwater resources. Monitoring results are presented in Table 20 above. WDA 1 and WDB 1 are controls.

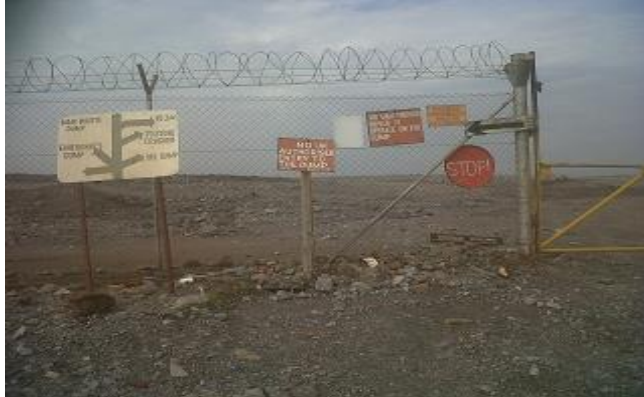
Fig.38: Waste Rock Dump A

In order to prevent illegal entry by unauthorized persons, appropriate warning signage is displayed at various points around the dumps. Table 16 below details the quantities of waste rock generated and disposed at licensed Dumps A and B.
