RE: BI-ANNUAL STATUTORY REPORT FOR KMRL KONKOLA MINE

BI-ANNUAL REPORT TO THE ZAMBIA ENVIRONDENTAL MANAGEMENT AGENCY (ZEMA) FOR THE PERIOD JANUARY TO JUNE 2024

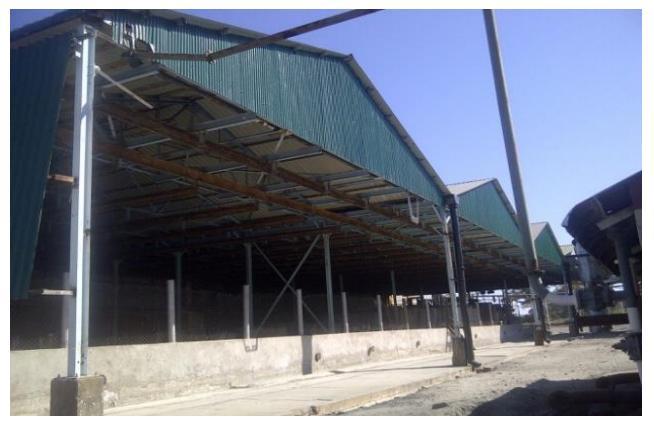
Fig.2: Reagents Storage Shed

1.1.1 Storage – All process reagents are kept at the central storage shed and transported on demand to the reagent mixing shed, which is under a roof and adequately bunded. The store is sized to hold approximately twelve month's operating requirements. A summary of the storage and use of reagents in the reporting period is provided in Table 1 below.

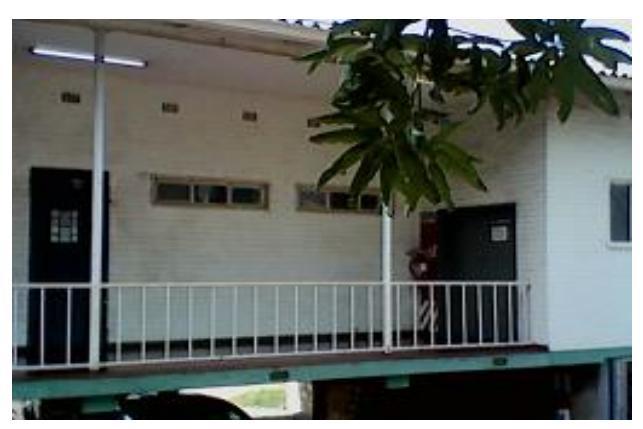
Fig.4: Reagent Storage Facility

- The storage room is properly constructed with concreted floor, surrounded by enclosed walls of sufficient strength with an iron roof and a steel door. Access to the facility is restricted.
- Emergency equipment/kit available consists of PVC Apron, gloves, gas mask, broom, container of absorbent (sawdust/sand), dust pan/spade, empty container for collecting cleaned material.

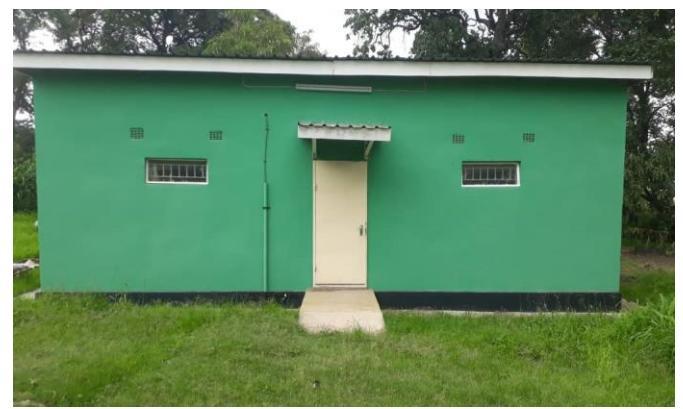
Fig.6: Pesticides Storage Facility

- The storage area is constructed with concreted floor, walls, roof and a steel door. Access to the facility is restricted as the area is under lock and key.
- Emergency equipment/kit available consists of PVC Apron, gloves, gas mask, broom, container of absorbent (sawdust/sand), dust pan/spade, empty container for collecting cleaned material.
- 1.3.1 **Fumigation** –A summary of the quantities of the pesticides and toxic substances used in the reporting period is provided in Table 3, and the medical records of personnel involved in the handling of these substances is provided are Table 4 below.

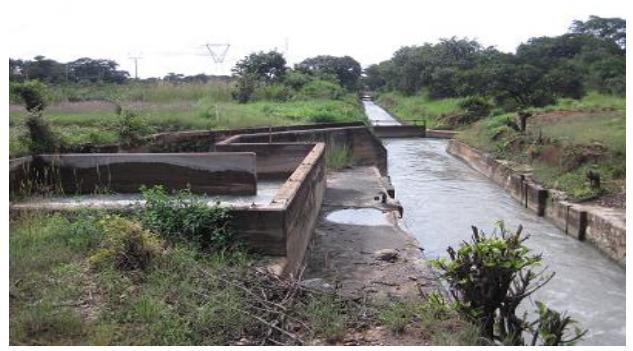
Fig.7: Combined Drain

Konkola Mine is one of the wettest mining operations in the world, and for the safe operation of the underground workings, it is necessary to pump approximately 350, 000m³/day of groundwater from the mine. This amounts to a continuous flow of approximately 4.1m³/s, which is ultimately discharged into the Kafue River.

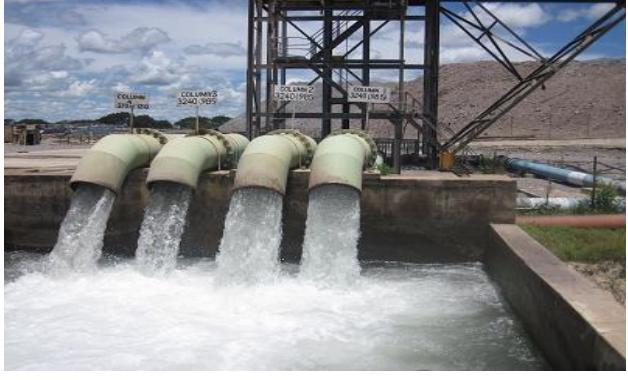
Fig.8: Pipe Columns from Underground

In order to dewater the Konkola underground mining operations, water is pumped from underground via the following multiple pipes:

- Two 500 mm (16") diameter pipes (new and old) and one 600 mm (20") diameter pipe which provide the process water for the concentrator plant
- One 1200 mm (48") diameter pipe, which discharges directly to the environment
- One 200 mm (8") diameter pipe, which discharges directly to the environment
- One 600 mm (20") diameter pipe, which is treated in sedimentation ponds for domestic water use
- One 200 mm (8") diameter pipe, which is treated in sedimentation ponds before discharge to the environment
- One 200 mm (8") diameter pipe, which is treated in a 250ft thickener before discharge to the environment
- Four 500 mm (16") diameter pipes, which discharges directly to the environment

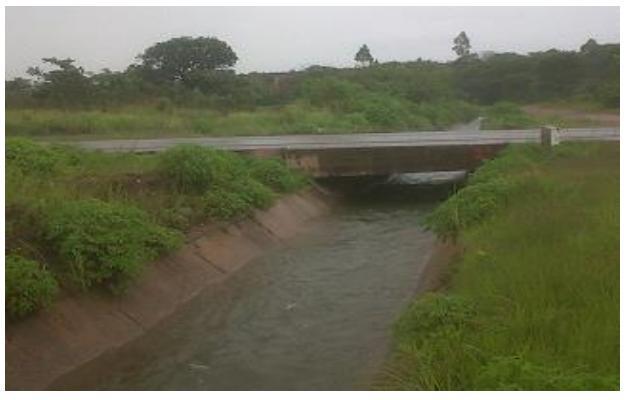
Fig.9: Lubengele Tailings Dam Overflow

The tailings from the existing concentrator are presently pumped to the Lubengele Tailings Disposal Facility. Overflow from the tailings dam is conveyed to the discharge point through the spillway. Accordingly, samples of discharge water are collected from the concrete channel downstream of the tailings facility (Discharge point 208). Table 10 below provides a summary of the monitoring results for the tailings dam overflow in the reporting period. Details of related incidents and causes are provided in table 10.

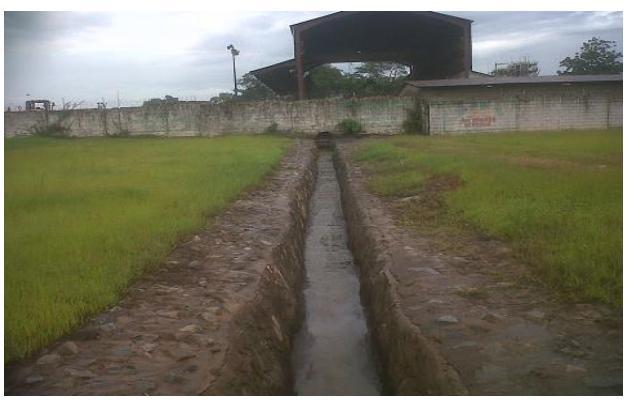
Fig.10: Engineering Workshops Drain

Routine service, repair and overhauls of equipment as well as cleaning of fuelling facilities require the use of water to a limited extent. Accordingly, samples of discharge water are collected from the concrete channel downstream of the central workshops on surface workshops at Engineering Services (Discharge point 225). Table 11 below provides a summary of the monitoring results for the engineering workshops overflow in the reporting period. Details of related incidents and causes are provided in table 14.

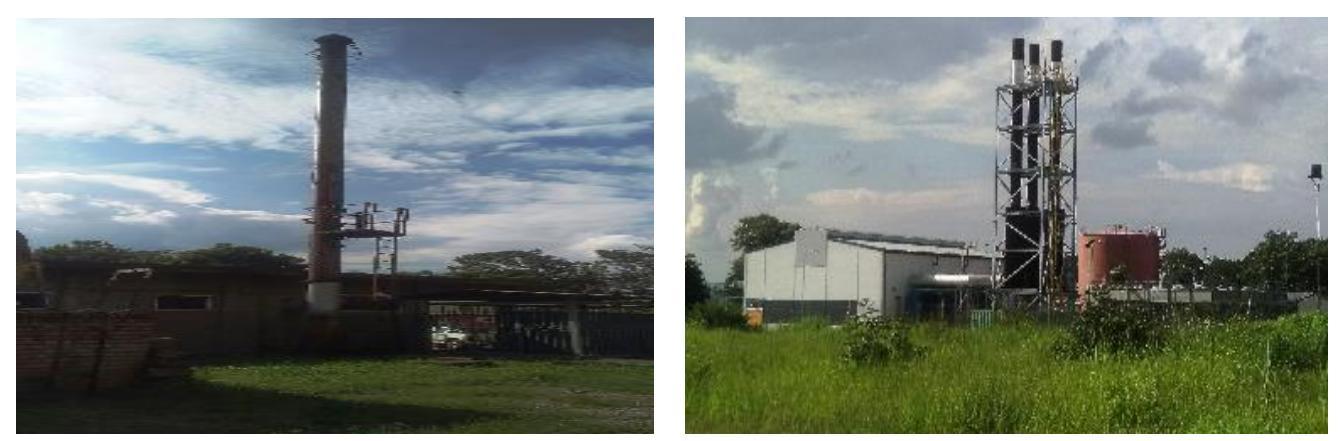
Fig.11: Hospital Incinerator Stack

Fig.12: Diesel Generator Stacks

• Solid waste from the mine hospital, including contaminated medical waste, is collected at the hospital, incinerated and the waste ash disposed of at the designated incinerator ash disposal facility which is a concreted below ground pit located about 800m on the southern side of No. 4 shaft.

The diesel generators were installed to provide power required for ventilation, man riding and pumping in an emergency. Table 13 below provides a summary of the monitoring results for the stacks. Details of related incidents and causes are provided in table 14.

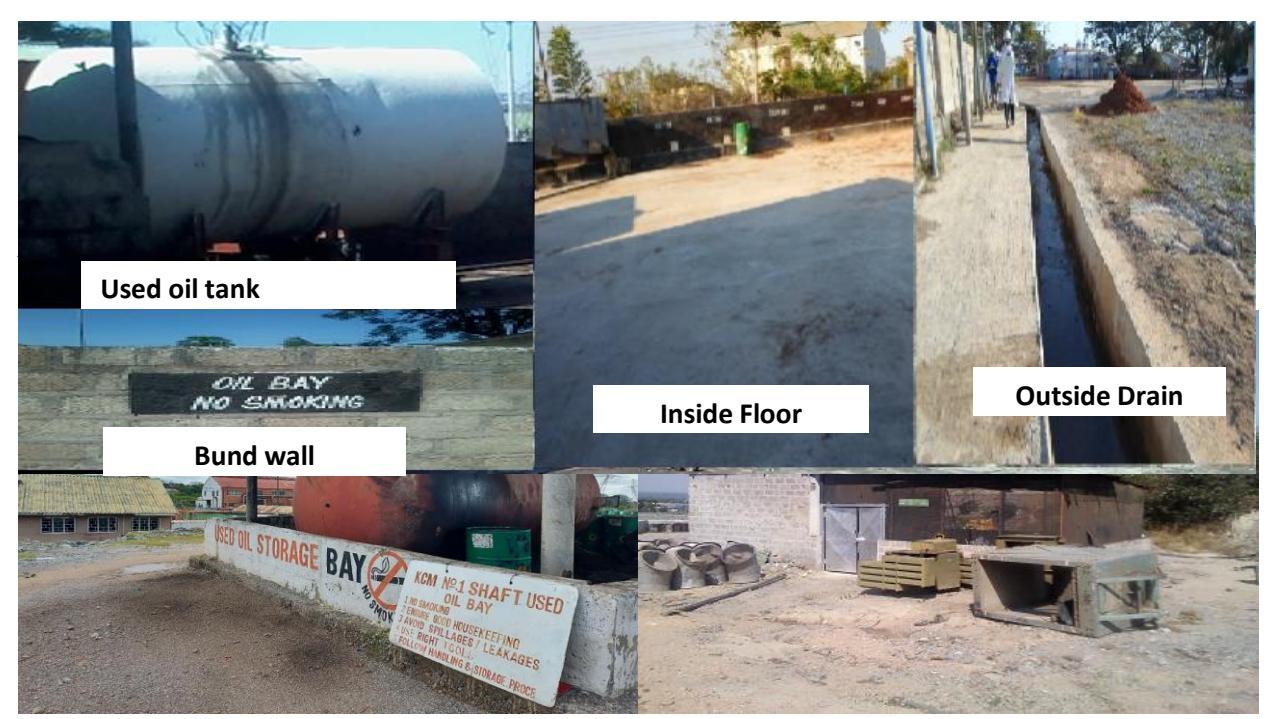
The plant generates hazardous waste namely; waste oil, used fluorescent tubes and used batteries. Waste oil is stored on constructed bays with impervious floors and bund walls and eventually reused at Nchanga Smelter as fuel. Spent fluorescent tubes are stored within the plant premises in fabricated storage drums while batteries are stored in the hazardous materials store before it is disposed of through recycling/reuse contractors. The quantities generated are presented in table 15 below.

Fig.14: Used Oil Store – Shaft 1

Fig.15: Used Batteries and Fluorescent tubes

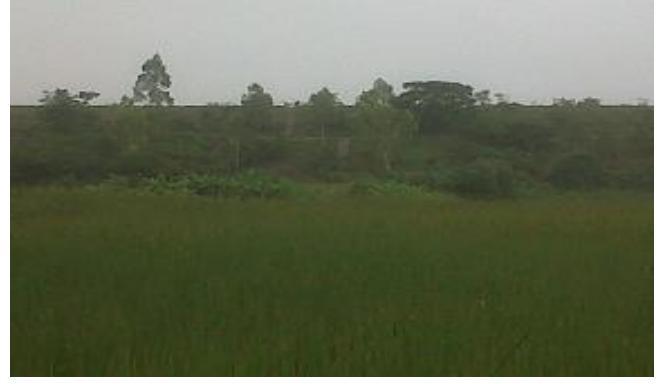
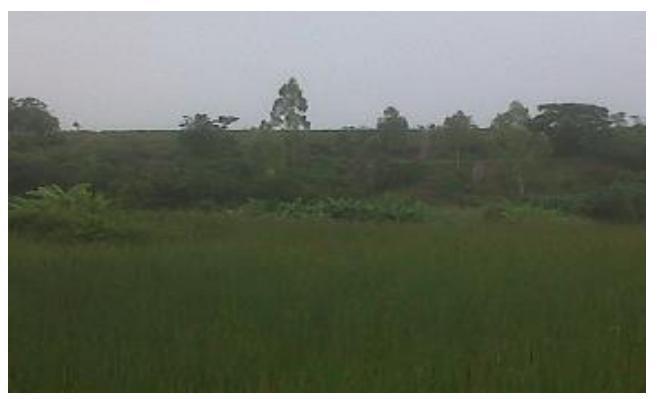
The eastern embankment of the tailings dam which susceptible to dust is generally maintained in good order with vegetation well established on most portions of the slope. There were no community complaints in the period under review

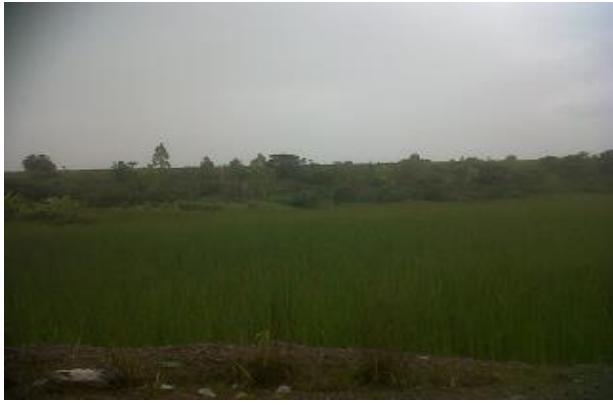
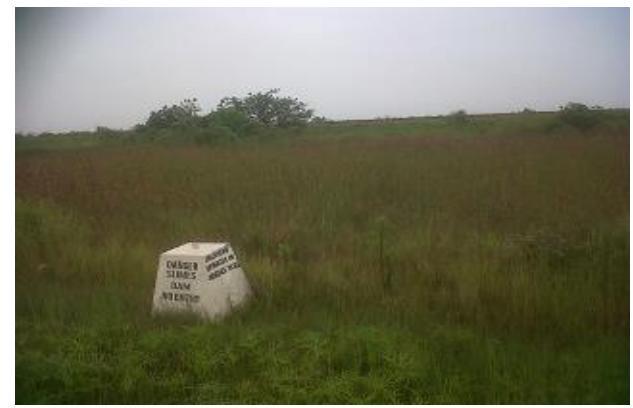
Fig.20: Lubengele Tailings Dam Surrounding Fig.21: Lubengele Tailings Dam Surrounding

Work towards revegetation of areas of the tailings embankments to reduce on erosion is undertaken on an ongoing basis. The replanting involves a selection of tree and grass species and stock is obtained from local suppliers.

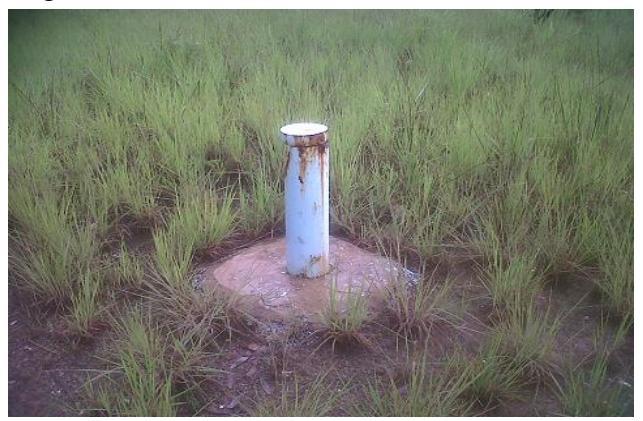
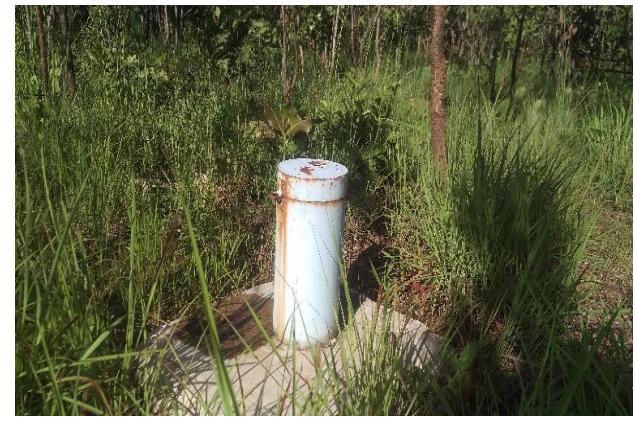
There are a number of dug wells adjacent to and upstream of the dam. Table 15 below shows the quality of groundwater around the dam. SDH19 and SDS01 are controls.

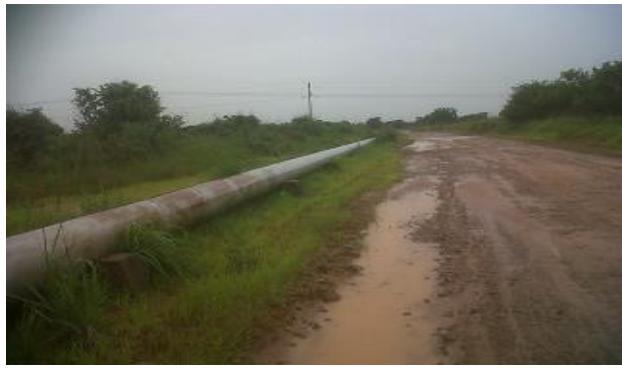
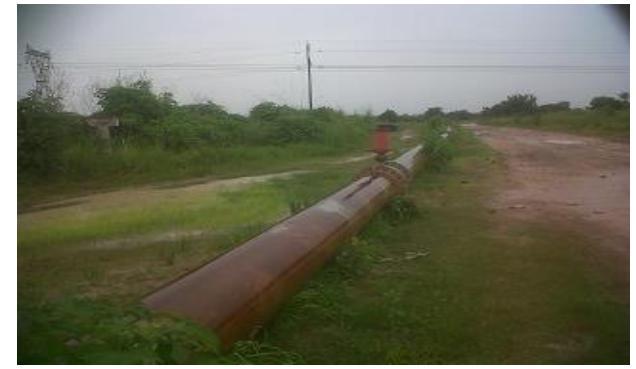
Fig.28: Lubengele Tailings PipelineFig.29: Lubengele Tailings Pipeline

• The tailings pipeline is a 300 mm diameter, 8.4 km long rubber lined steel pipeline which delivers tailings from the process plant for disposal in the tailings facility. The pipeline was newly installed with a 25 year guarantee. A second tailings pipeline is available for use during maintenance of the main pipeline.

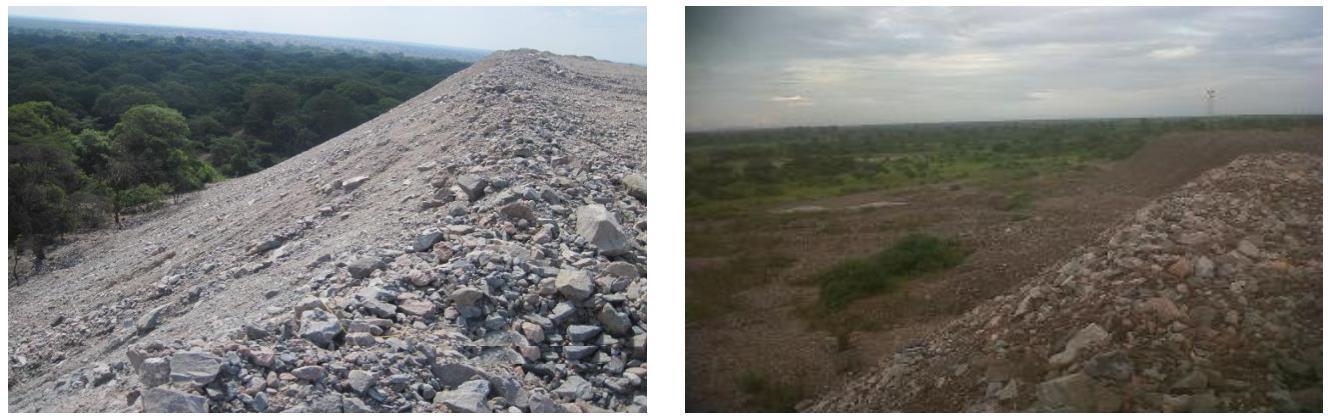
The dumps are generally well maintained. Both dumps are currently being reclaimed for building/construction material. Slopes are stable and top surfaces well maintained. Tension cracks are filled as they appear.

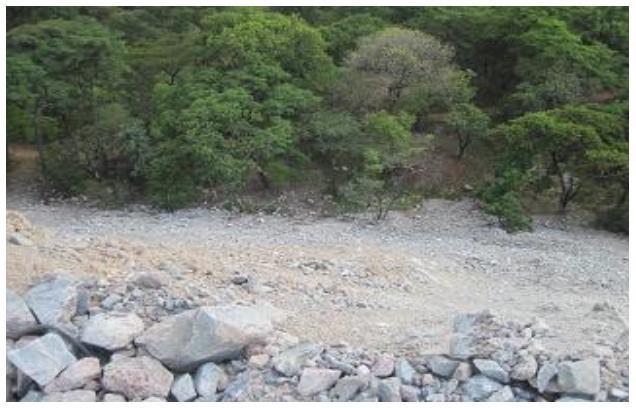
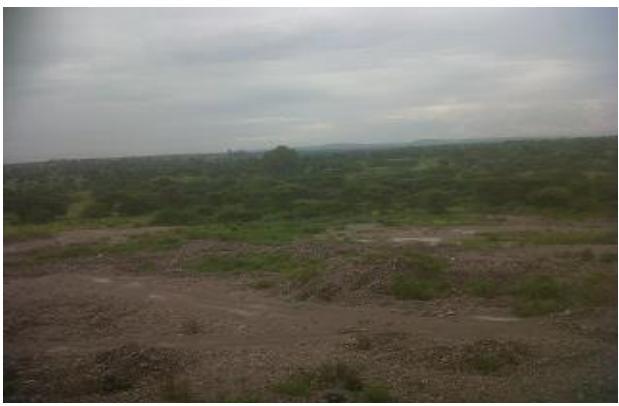
There is no vegetation on the dump. The surrounding areas are however well vegetated with no evidence of negative effects arising from erosion.

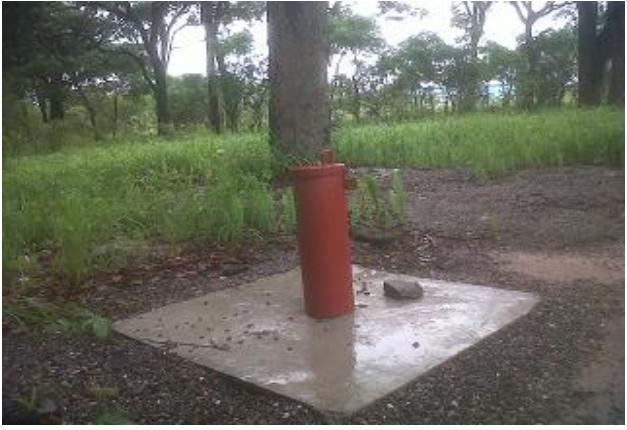
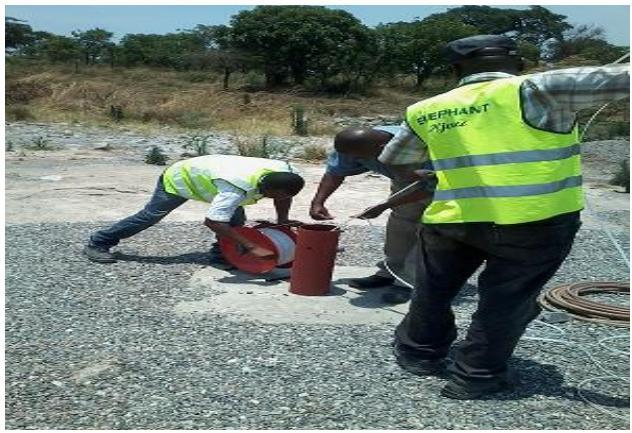
There are two monitoring boreholes on each waste rock dump to monitor the quality of groundwater to ascertain whether our operations are impacting on the groundwater resources. Monitoring results are presented in Table 20 above. WDA 1 and WDB 1 are controls.
